# **BUTRINT FOUNDATION**

Field Projects 2007 Interim Report

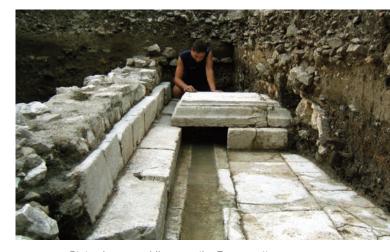
Statue base moulding over the Forum gutter.

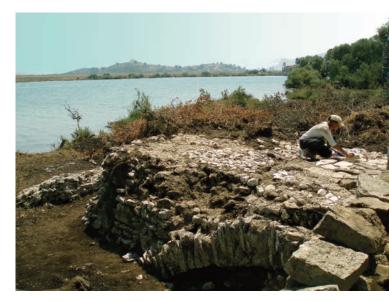
The first span of the Roman Bridge showing the paved surface.

A section of smooth stone paving was uncovered on the top of the Bridge; this is thought to be the original road surface, although rougher, later repairs were also identified. The road disappears to the west beneath later walls and medieval rooms attached to the Water Gate, but reappears at a lower level in a more monumental form beside the Nymphaeum. From the assembled evidence it is now apparent that the Bridge measured at least 6.50 m across, sufficiently wide to permit wheeled vehicles over the Vivari. Out in the channel, a wooden section, perhaps even with a lifting bridge, seem plausible fixtures to admit larger vessels into Lake Butrint.

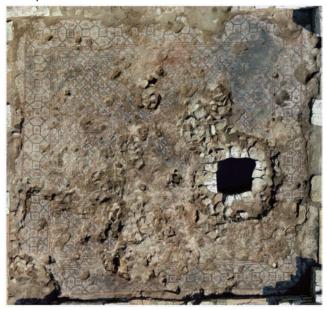
Photogrammetric image of the mosaic pavement in the western entrance vestibule of the Triconch Palace.

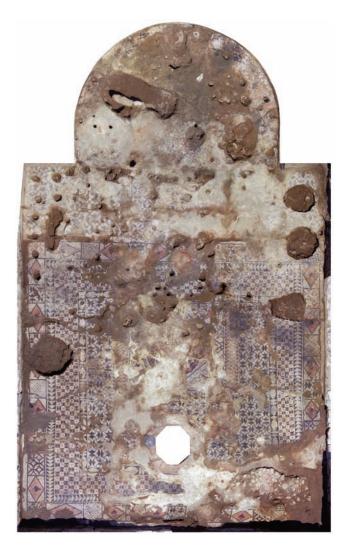
Photogrammetric image of the mosaic pavements in the apsidal *triclinium* of the Triconch Palace.

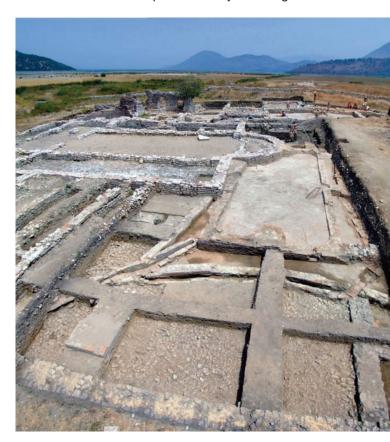
Early-mid 1st-century AD cobbled yard and 3rd-century AD ornamental pool and drains.

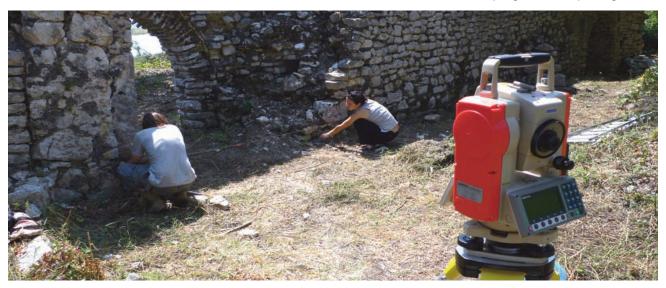
Establishing a survey grid of 3-D reference points for photogrammetric recording of the Water Gate.

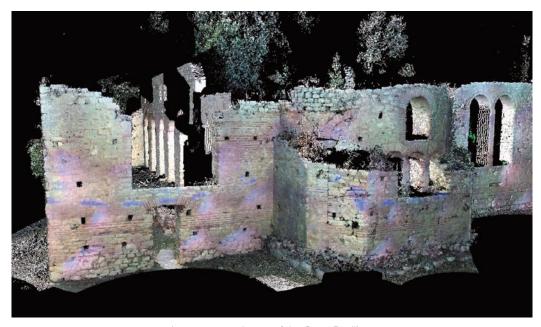
Laser scanner image of the Great Basilica.

The Great Basilica, already the subject of detailed architectural and historical appraisal and documented in depth by photogrammetry, provided the ideal set piece upon which to field test the apparatus. Traditional and progressive recording methods would provide a benchmark against which to measure the suitability of this cutting edge technique. Whilst the aisles of the Basilica – that is to say, its interrupted surfaces – would always be a challenge for the scanner requiring repeated repositioning of the equipment, both the interior and exterior of the monument were nevertheless surveyed within just two days, the scanner collecting 400 million points.

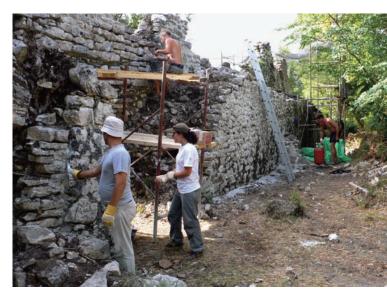
Conservation team consolidating the interior face of the Water Gate.

Situated close to the Great Basilica, the Water Gate was one of the most prominent entrances into Butrint from the 13th century onwards. Some 800 years after its initial construction, the Butrint Foundation's condition survey showed that the gate was in a dreadful state of repair: thick tree roots had penetrated the core of the stonework causing splits and disintegration whilst

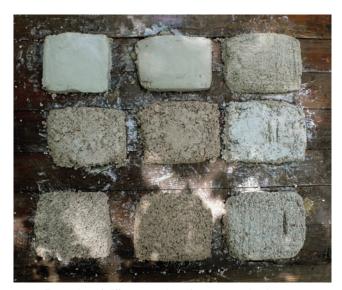
Examples of different grades of mortar used to instruct conservation trainees in mixing period replica mortars.
